# WreckProtect

Strategies for the protection of shipwrecks in the Baltic Sea against forthcoming attack by wood degrading marine borers.

A synthesis and information project based on the effects of climatic changes.

FP7-ENV-2008-1

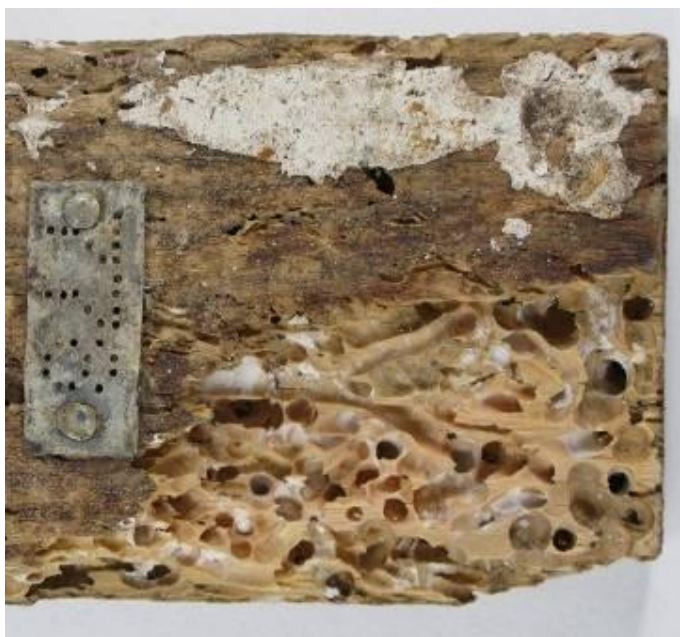
Figure 2. Heavy attack by *Teredo navalis*. The mollusc penetrates and digests the wood material forming up to one centimetre wide tunnels.

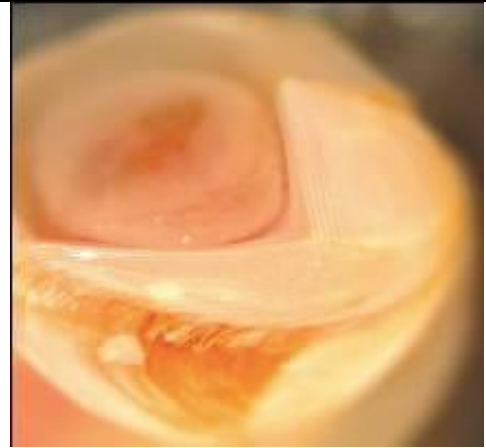
Fig. 3b. Shell and muscular foot ( $\varnothing$  5mm) of an adult *T. Navalis*. Photo C. Appelqvist.

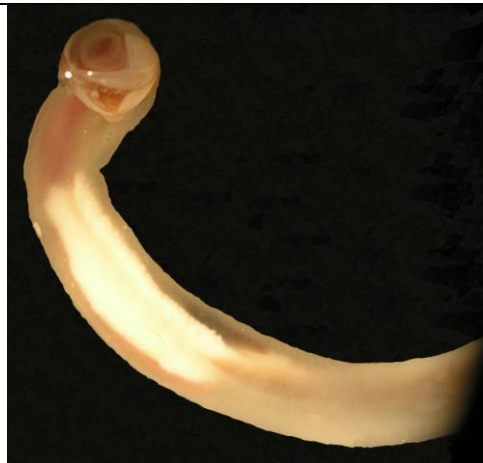
Figure 3c. Front part of an adult shipworm, 60 mm long.

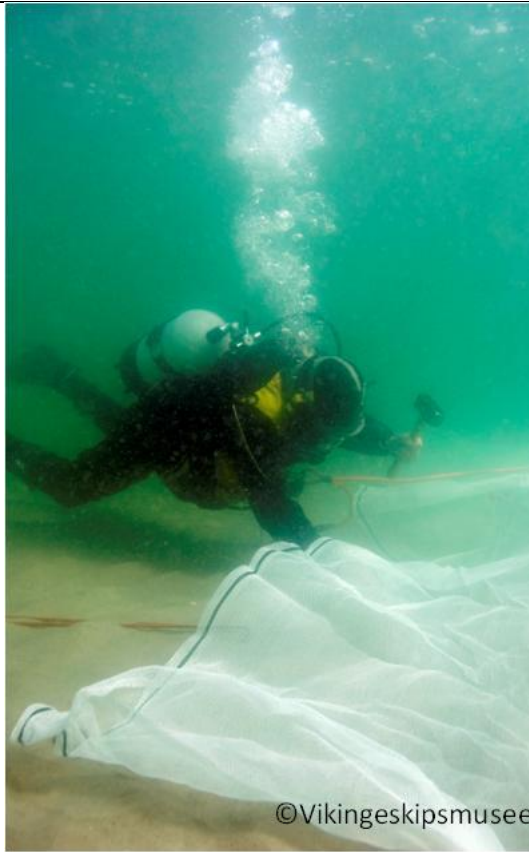
Fig. 7a. Debris-netting tracks sediment and a protective layer is built up above the timbers

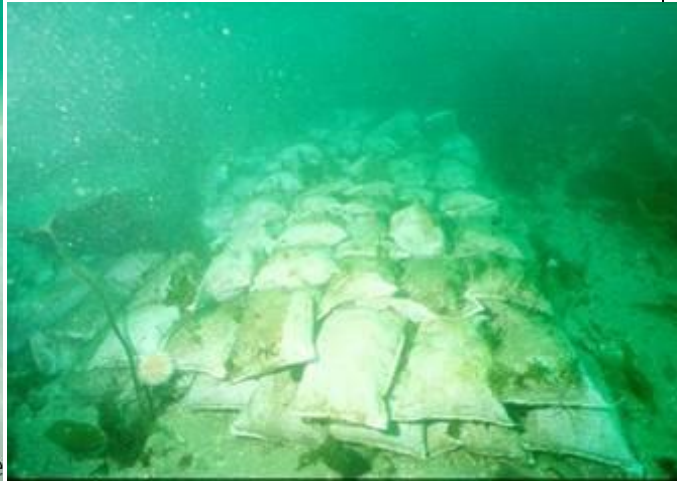
Fig. 7b. Sand bags are an efficient method for securing the sediment layer above the wreck site and establishing unfavourable conditions for biological attack.
