DEVELOPMENT & VALIDATION OF AN AUTOMATED NON-DESTRUCTIVE EVALUATION (NDE) APPROACH FOR TESTING WELDED JOINTS IN PLASTIC PIPES

Development and validation of automated non-destructive(NDE) System for testing welded joints in plastic pipes

Development of an Automated Phased Array Ultrasonic Inspection System and Flaw Acceptance Criteria for Welded Joints in Polyethylene Pipes

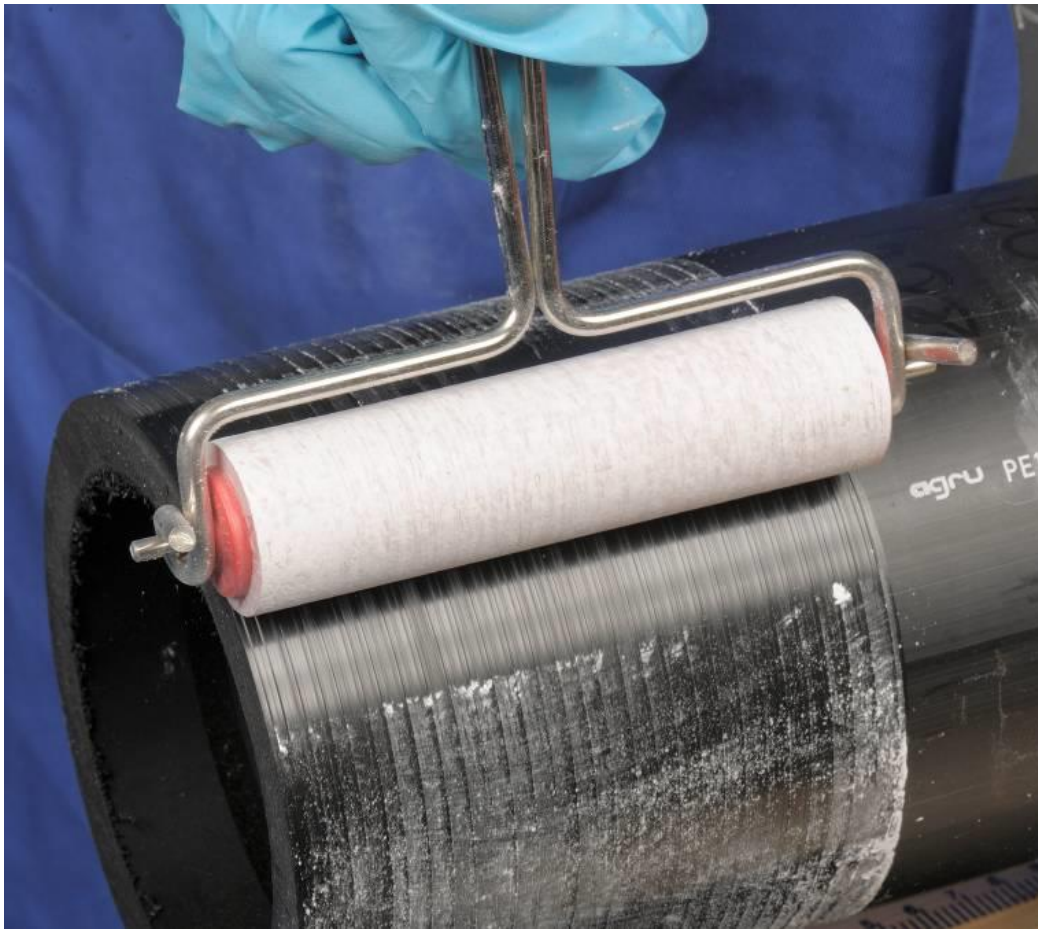
Figure 10 Standard talc-contaminated pipe samples for butt fusion welding.

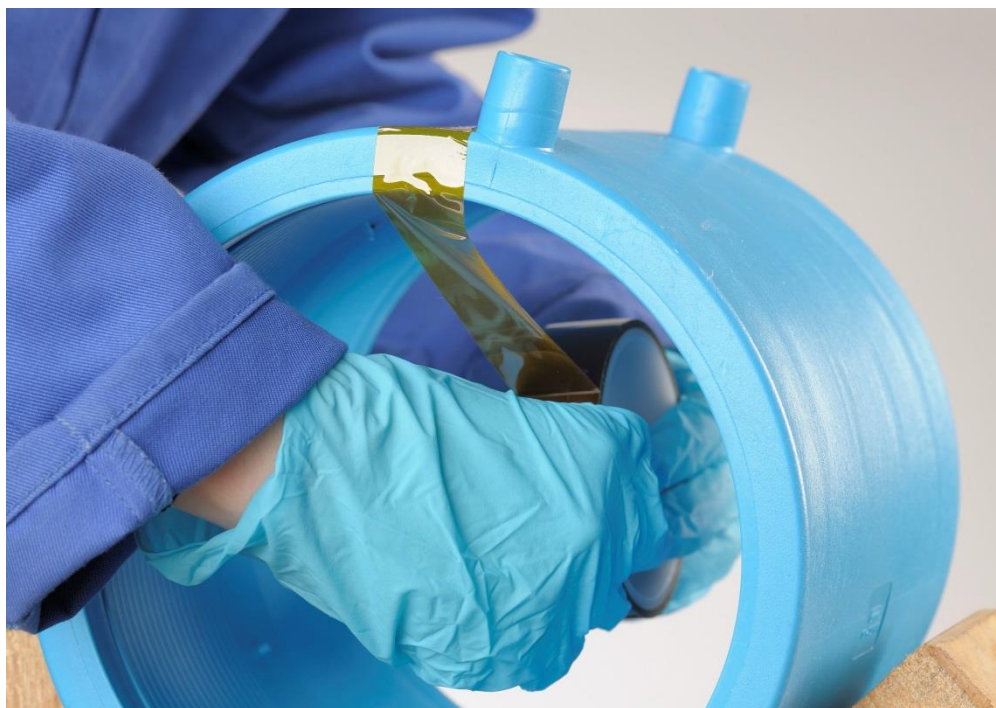
Figure 13 Application of polyimide tape to the trimmed end of a PE pipe.

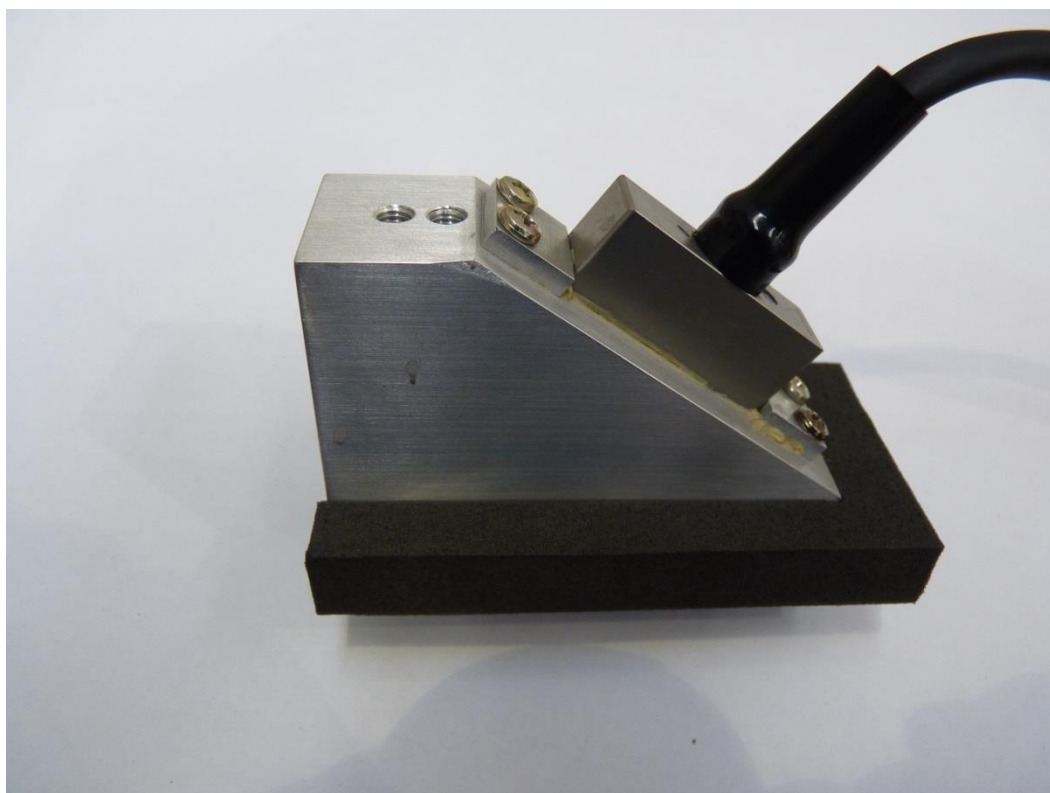
Figure 36 0° water wedge for inspecting EF joints, with phased array probe and sealing skirt attached.

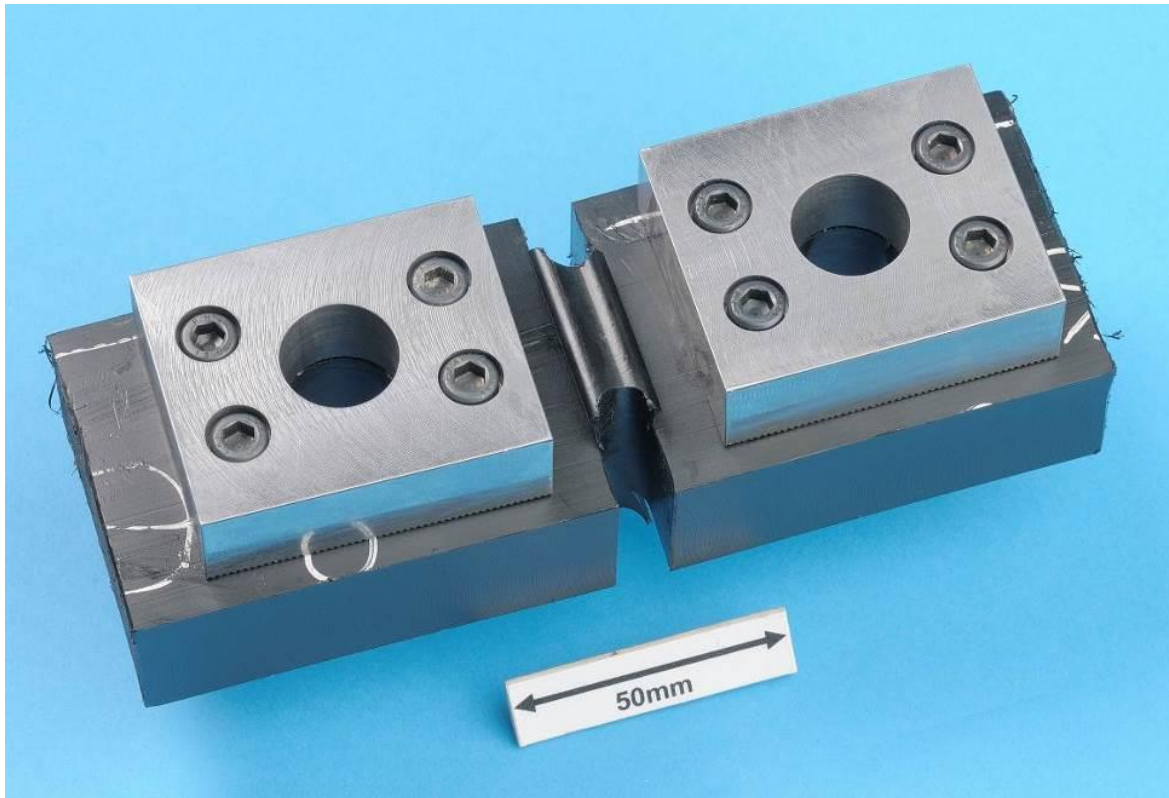
Figure 62 Waisted tensile test specimen geometry.

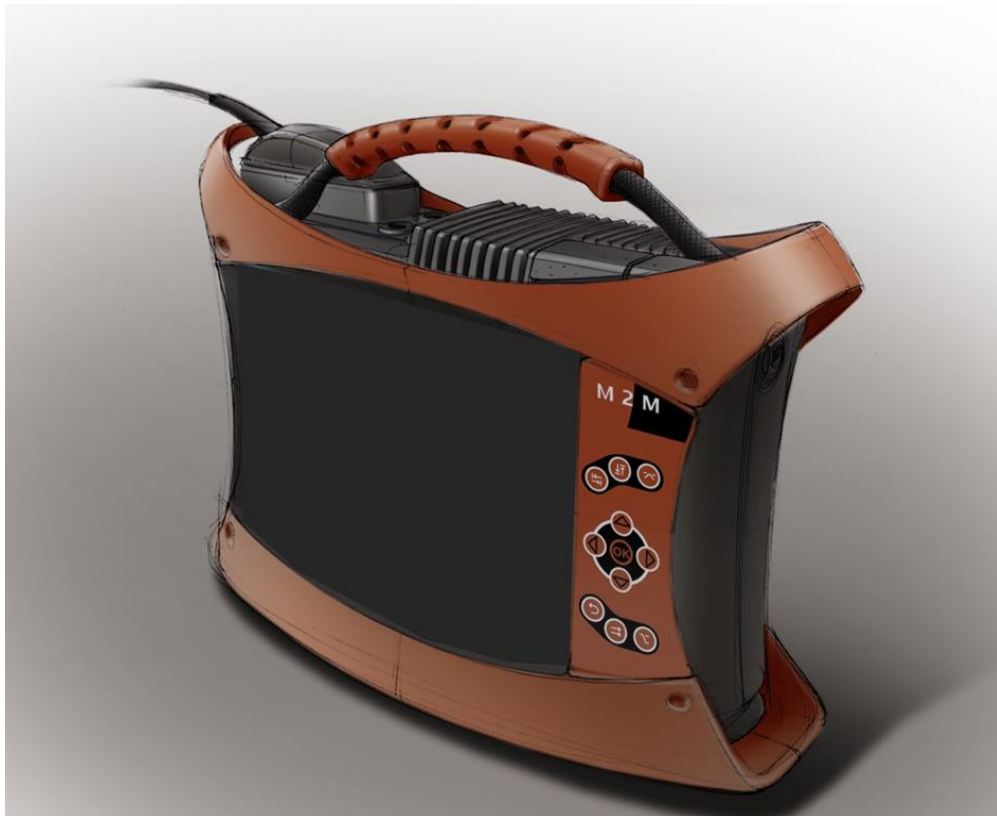
Figure 90 CAD design of the prototype ultrasonic instrument.

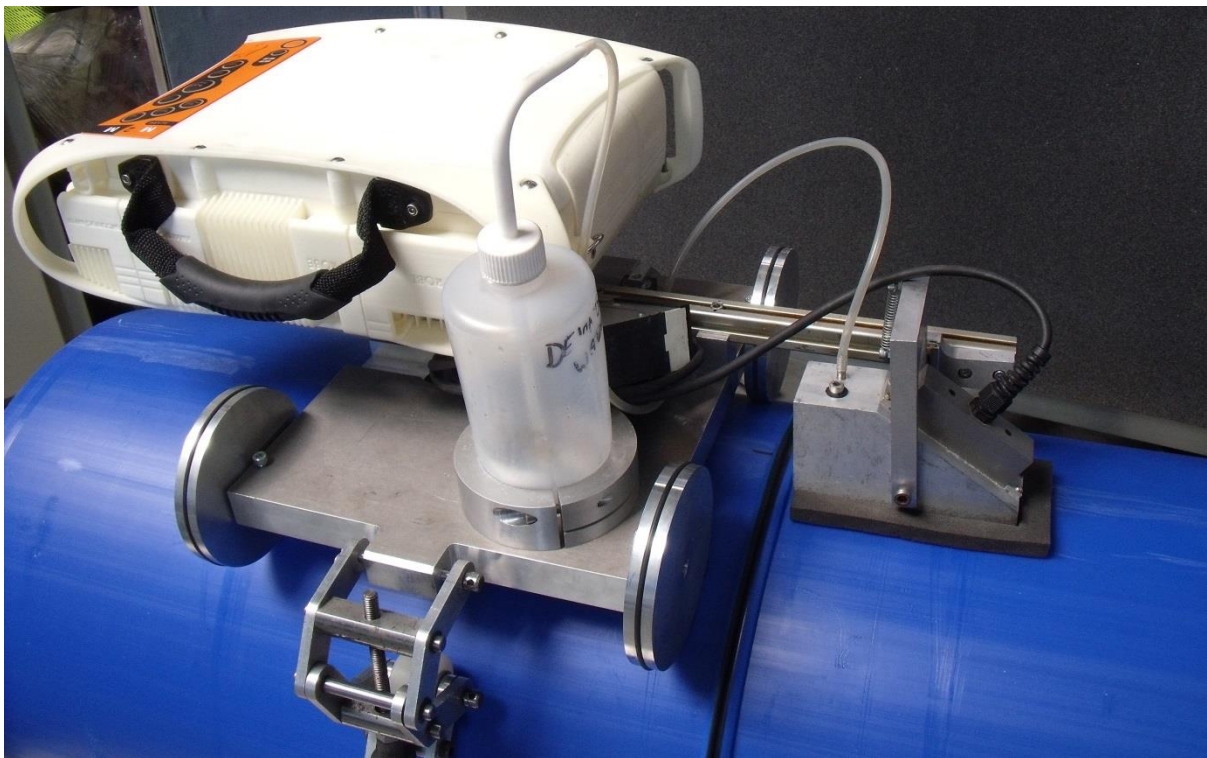
Figure 97 Carriage for inspecting large diameter pipes, with ultrasonic instrument and water reservoir attached.

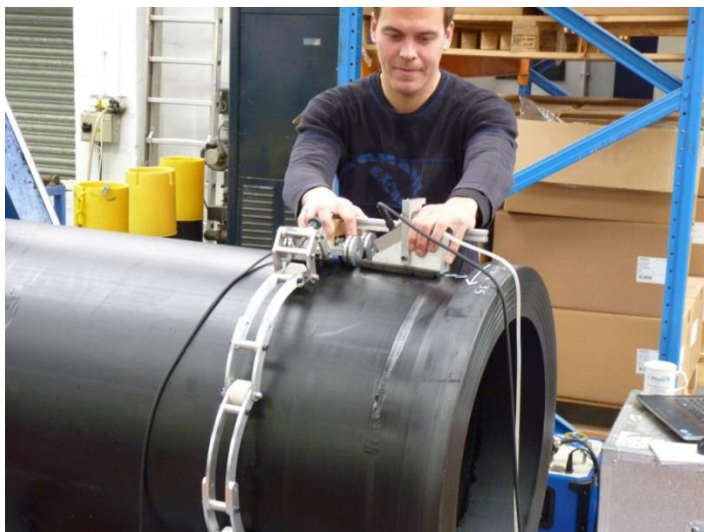
Figure 104 Inspection of a butt fusion joint at Plasflow.
