**Figure 3** Feasibility Article DEfcodoor Project

**Figure 4** Planed demonstrators for the GRC6.2 Project (ECO-Fairs): a) and b) Radom; c) sponson fairing (AW)

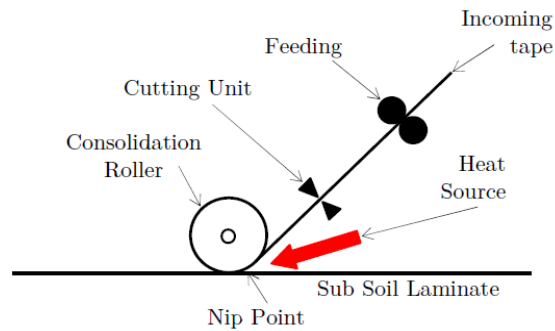
**Figure 1** Schematic of the AFP process for composites with thermoplastic matrix [13]

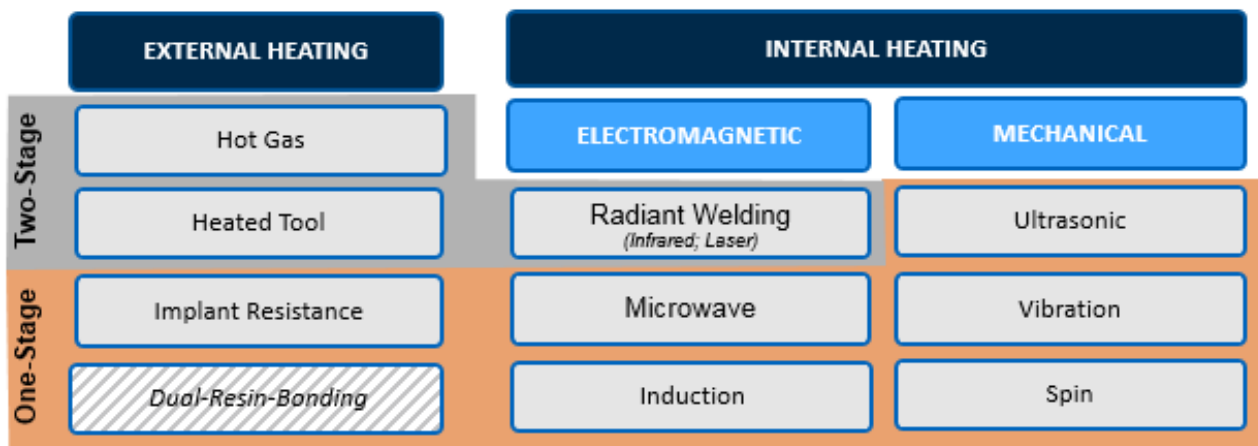
**Figure 5** Classification of different welding methods for TPCs

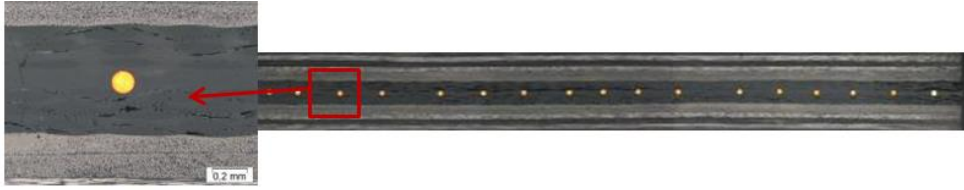
**Figure 14** Light optical micrographs of the embedded final design of the separation layer

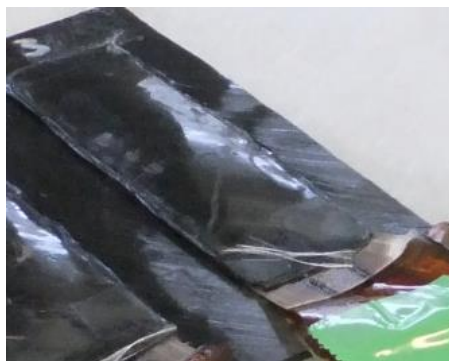
**Figure 16** Picture of test specimen 2 (a) and test specimen 3 (b) after separation test. Exemplary thermographic image of disassembly coupon (c)

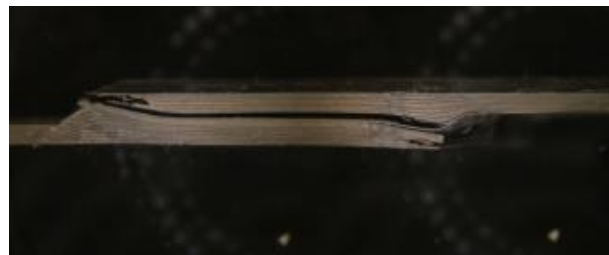
**Figure 18** Side view of single lap shear test specimen (without separation layer) with tape undulation

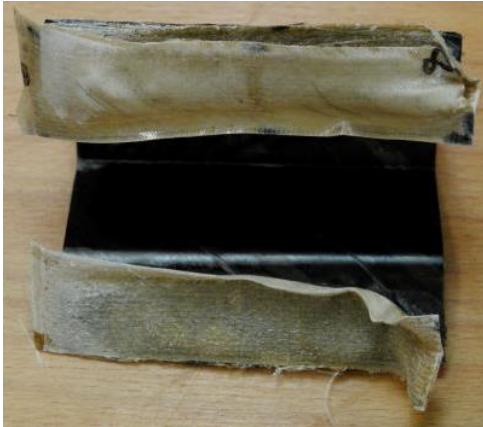
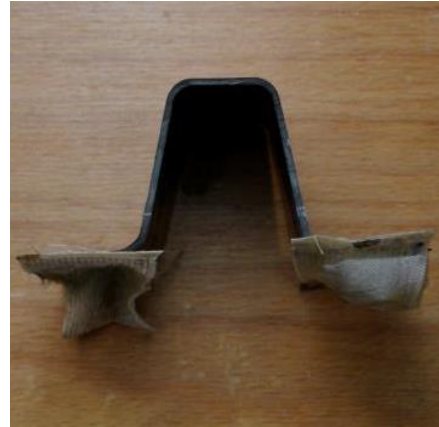
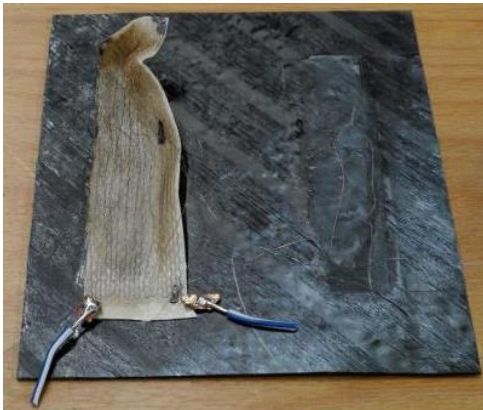
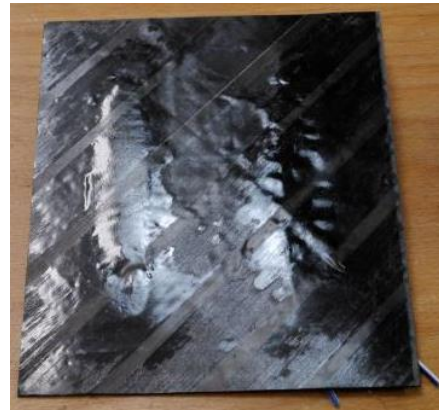
**Figure 23**      Disassembled omega stringer from skin
